Dog River River Corridor Plan

Roxbury, Northfield, Berlin & Montpelier,
Vermont
April 8, 2009

Prepared by: Bear Creek Environmental, LLC

Prepared for: Town of Northfield, Vermont

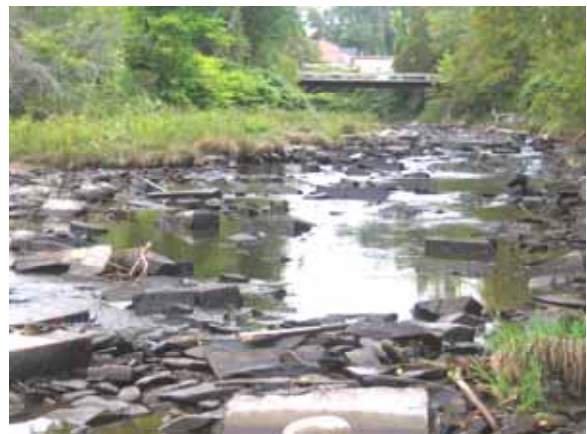
Figure 5.30: Granite tailings in channel downstream of footbridge behind Mobil Station on N. Main Street

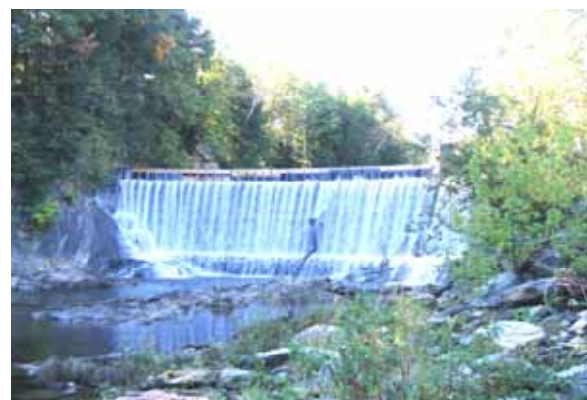
The RGA ranked in the fair category due to extreme historic degradation and minor widening and planform adjustment. M11-C is an "F" channel as a result of extreme historic incision due to being sediment starved below the large hydroelectric dam in M11-D (Figure 5.31). The channel no longer has access to its floodplain as a result of this incision and has undergone a stream type departure from its reference "C" stream

Figure 5.31: Northfield Mills hydroelectric dam near Belknap Street

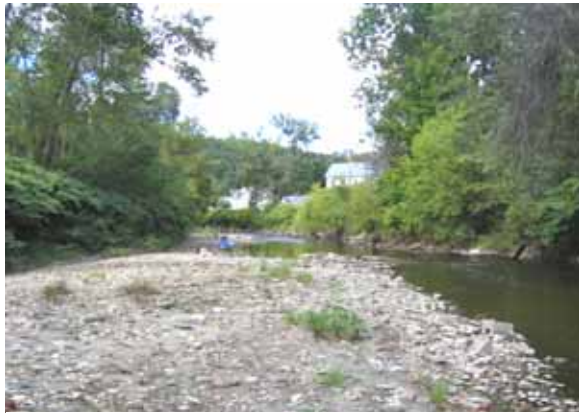
The RGA ranked in the fair category due to extreme historic degradation and major aggradation and planform adjustment. M12-B is a "B" channel as a result of extensive channelization and development within the riparian corridor. The channel no longer has access to its floodplain as a result of this incision and has undergone a stream type departure from its reference "C" stream type. The RHA also scored in the fair category due to limited refuge habitat, historic channelization, alteration of runoff characteristics and poor riparian and near bank vegetation.

Figure 5.34: Residential development within corridor, invasive bank vegetation and large side bar near the intersection of Water Street and Carpenter Street

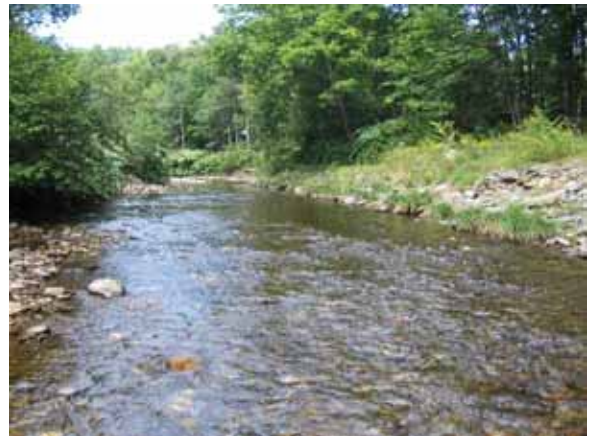
Figure 5.39: Straightened channel with limited near bank vegetation and riparian buffer near end of Expansion Drive.

The RGA scored in the fair category due to major aggradation and planform adjustment, and minor widening and historic degradation. M15 is a “C” channel that has historically incised (incision ratio=1.3) and has lost some access to its floodplain. The RHA ranked in the fair category due to limited woody debris cover, limited refuge habitat, and inadequate vegetation on the near bank and within the buffer on the east side of the channel. This reach has several deep pools.

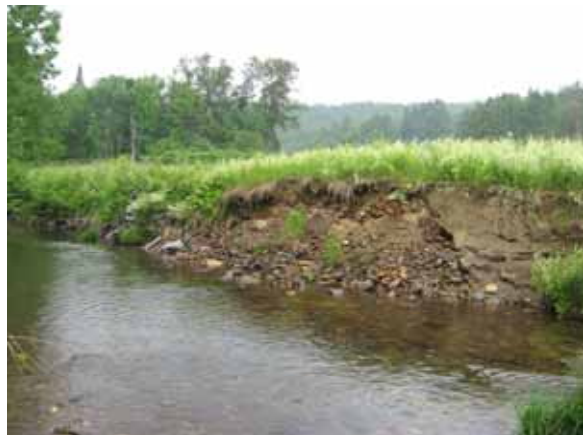
Figure 5.45: Agricultural field lacking riparian buffer and eroding banks near Little Northfield Road and Route 12A

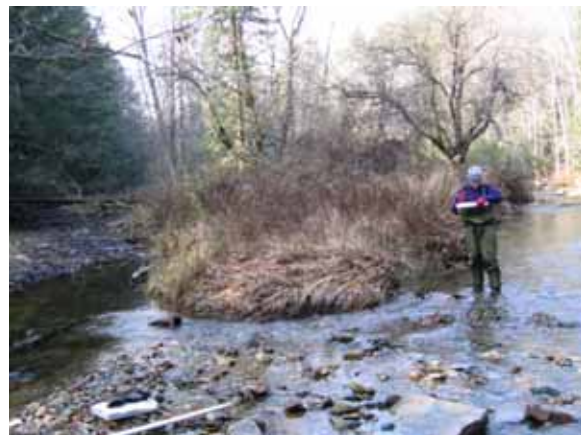
Figure 5.67: Lower end of large channel avulsion with active flood chute near intersection of Smith Hill Road and Stony Brook Road

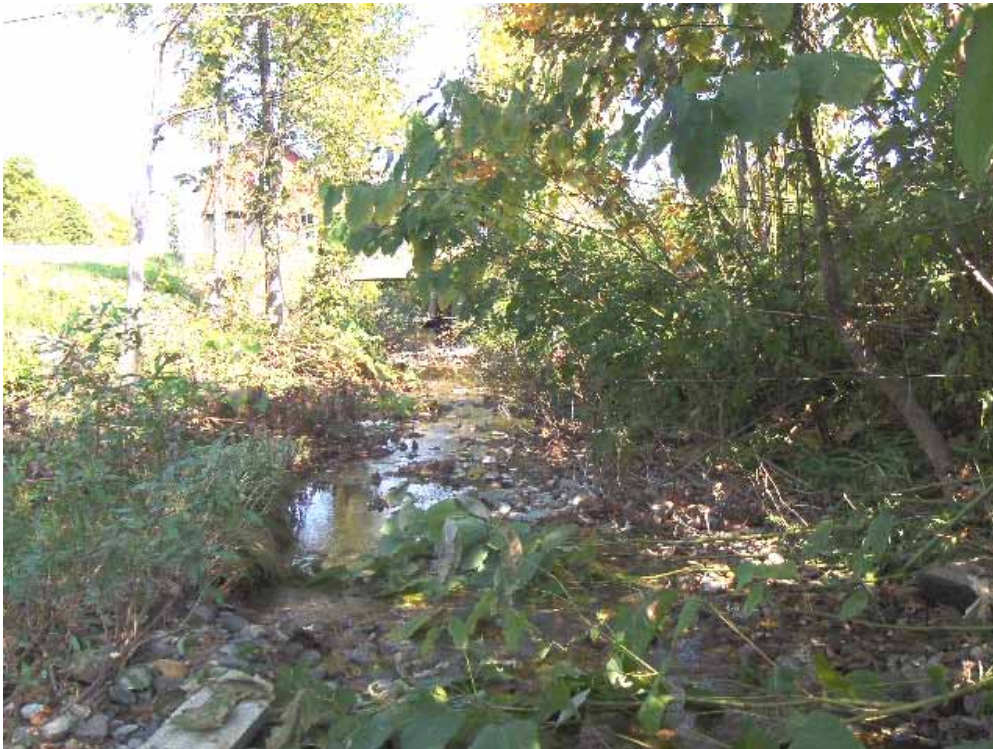
Figure 5.78: Segment M21-D received a habitat rating of poor due to channelization, channel encroachments, lack of riparian vegetation and little refuge habitat.
