Dog River River Corridor Plan

Roxbury, Northfield, Berlin & Montpelier,
Vermont
April 8, 2009

Prepared by: Bear Creek Environmental, LLC

Prepared for: Town of Northfield, Vermont

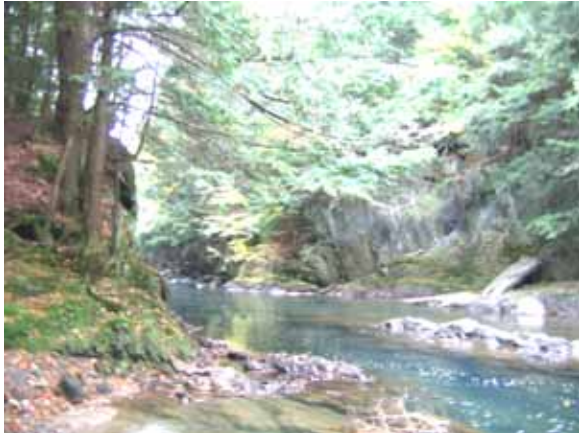
There is healthy near bank and riparian vegetation on both sides of the channel. This segment has large deep pools and is dominated by bedrock on both the bed and the banks (Figure 5.15). A very large waterfall exists at the upper end of the segment (Figure 5.16). The RGA and RHA were not evaluated for this segment. M07-B is a "Gc" channel by reference that is entrenched in a narrowly confined valley with a low slope.

Figure 5.15: Bedrock gorge near Route 12 and Gordon Drive

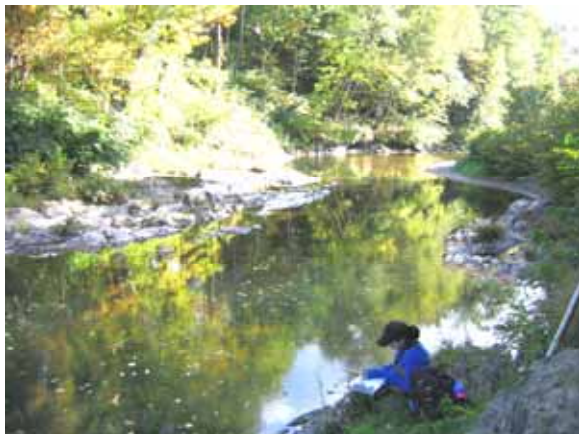
Figure 5.25: Deep pool and scour above bedrock constriction and Slaughterhouse Road Bridge

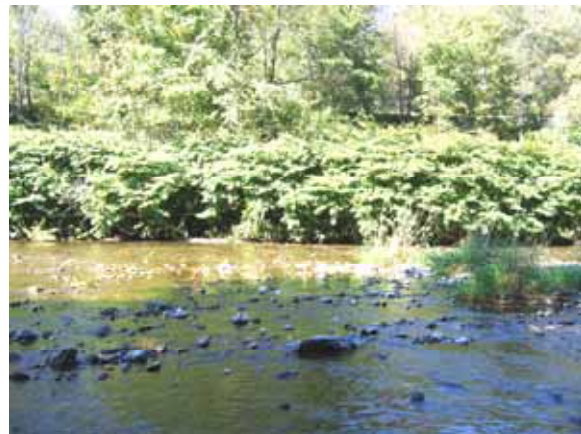
Figure 5.26 Invasive Japanese Knotweed along west bank with railroad bed in background upstream of Slaughterhouse Road Bridge

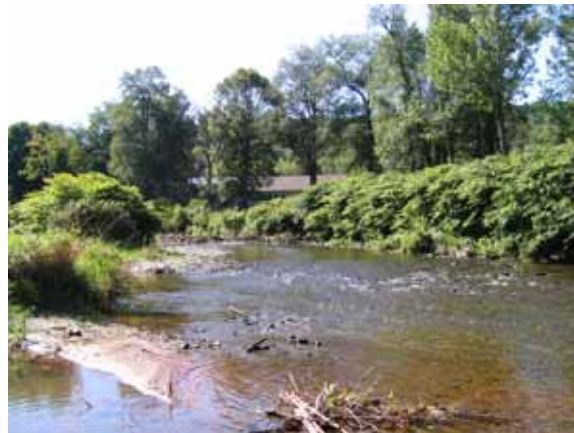
Figure 5.28: Invasive near bank vegetation and lack of riparian buffer near the Dogwood Glen housing development off N. Main Street

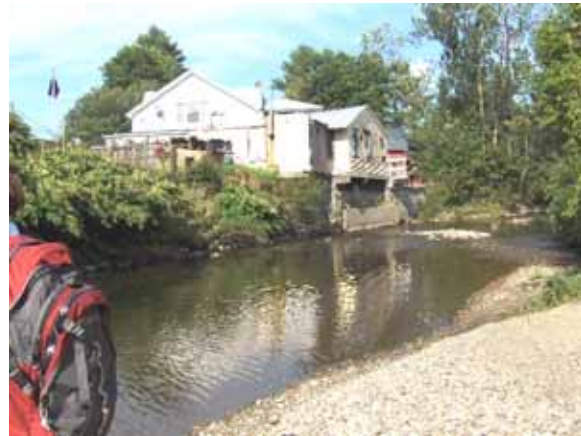
Figure 5.36: Houses built along Dog River on Water Street near intersection with Western Avenue

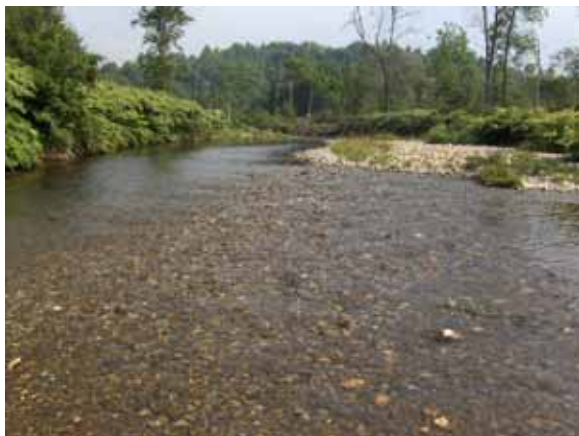
Reach M14 begins just below a railroad bridge below the Northfield Town Wellfield and ends at the confluence with Sunny Brook near Fairground Road. Multiple steep riffles, diagonal bars and flood chutes indicate increased aggradation and planform adjustment in this reach (Figure 5.37). Riparian land uses on the west side of the channel is primarily forest, while residential land use dominates the east side of the channel (Figure 5.38). The riparian buffer is less than 25 feet wide in many places along the east bank and both the near bank and riparian vegetation include invasive species on both sides of the channel. The railroad crosses the channel at the lower end of the reach via a bridge located well above the channel, with one pier in the middle of the channel causing major deposition to the west of the pier. This reach has been considerably straightened and minimally armored.

Figure 5.37: Large diagonal bar and invasive bank vegetation near downstream end of Northfield Town Wellfield

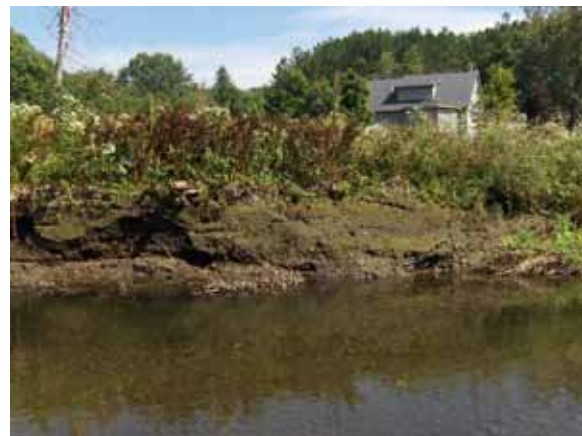
Figure 5.38: Residential property lacking bank vegetation downstream of confluence with Sunny Brook

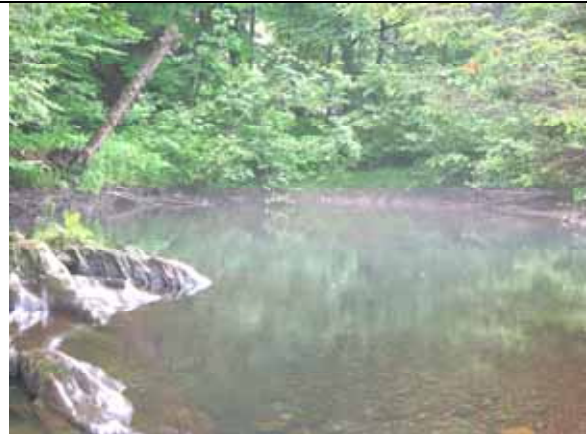
Figure 5.46: Large, deep pool at sharp bend downstream of Little Northfield Road

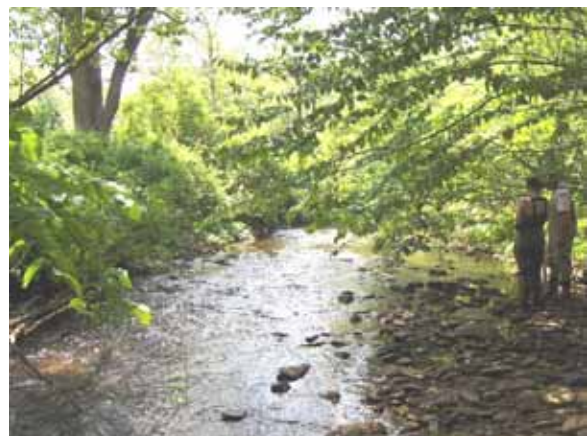
Figure 5.47: Healthy near bank vegetation downstream of Route 12A bridge near Potato Hill Road.

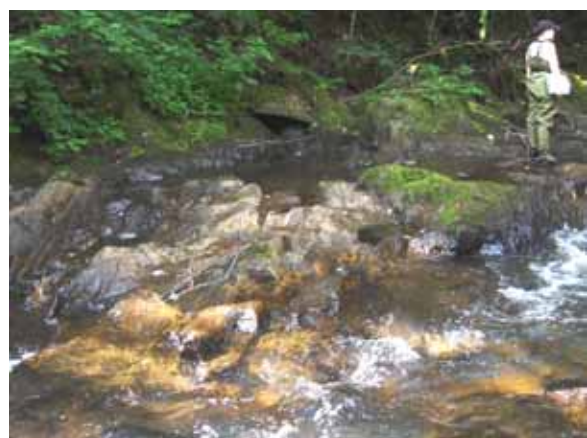
Figure 5.48: Bedrock stream banks in gorge segment near railroad bridge and Potato Hill Road.

greater than 100 feet. The banks are bedrock dominated and are in good shape (Figure 5.48). The railroad crosses the channel in this segment at a very high elevation that does not impact the channel as a constriction. This gorge-segment is an “F” stream type that does not have floodplain access by reference.

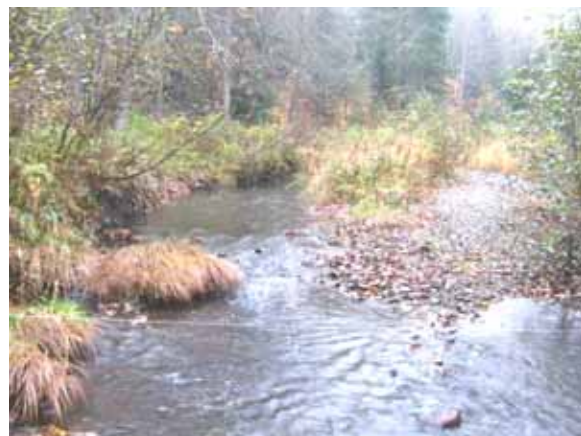
Figure 5.52: Large diagonal bar and steep riffle just over Roxbury town line above Rabbit Hollow Road

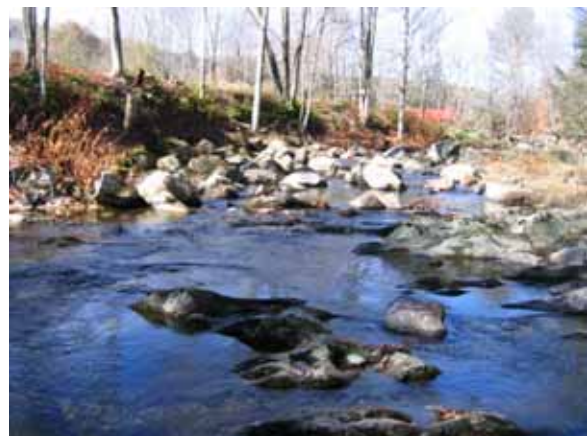
Figure 5.61: Bedrock and boulder dominated substrate with residential development within right corridor upstream of Jerry Road

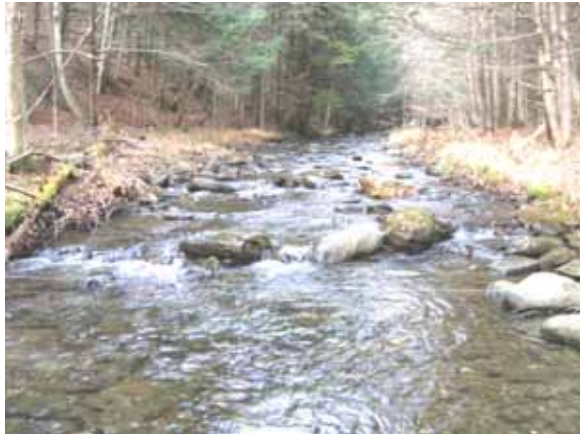
Figure 5.72: Channel with floodplain access and nice riparian vegetation above bedrock gorge

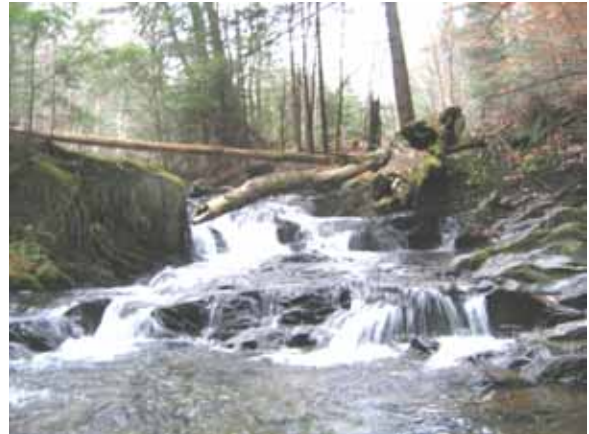
Figure 5.73: Bedrock waterfall with woody debris downstream of Murphy Road crossing

The RGA rated in the good category due to minor aggradation and minor planform adjustment as evidenced by five flood chutes and numerous small side bars. T6.01-C is a “Cb” stream type that has not historically incised. Some areas of this segment were slightly more entrenched, but overall the channel had good floodplain access. The RHA also scored in the good category with abundant woody debris cover, several deep pools and healthy riparian buffers. This segment has limited refuge habitat and many bankfull obstructions (bedrock grade controls).
